研究テーマーµフォーカスX線CTによる補強材引抜き抵抗力特性の解明

Research theme – Investigation of resistance force expression mechanism of pulled out reinforcement material by microfocus X-ray CT

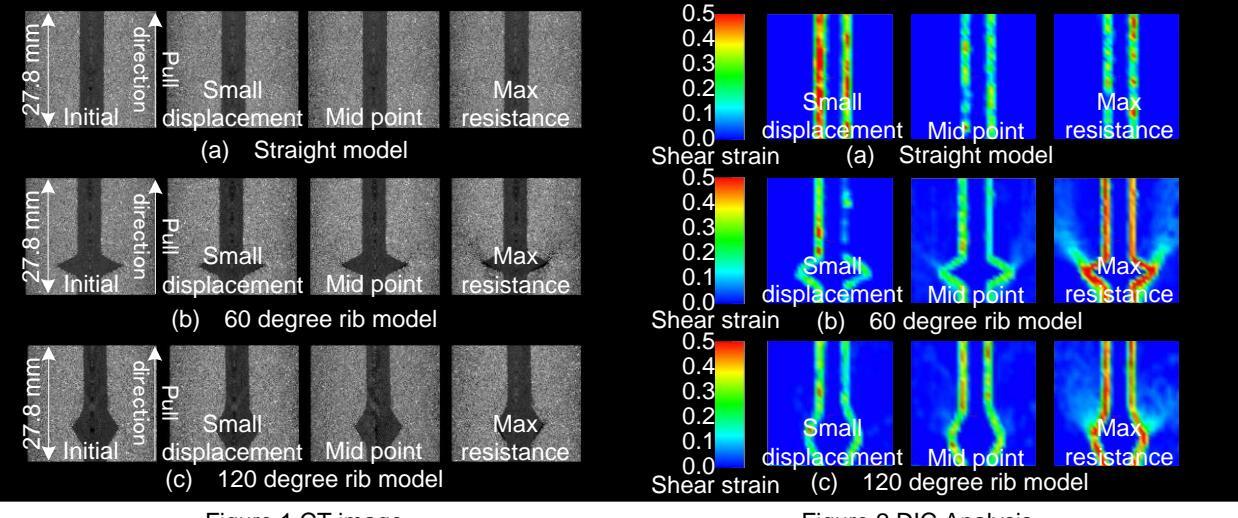
Figure.1 CT image

Figure.1 は補強材の引抜きによって生じた地盤内部構造変化を明らかにしたものである. CT 画像からも、補強材の引抜によって地盤内部の構造が変化し、またその傾向は補強材のリブ形状によって異なることが分かる. Figure.2 は画像解析結果の一例である. 画像相関法 (DIC)によって、せん断ひずみはFigure.1 の低密度領域に集中するとともに、その発生傾向も Figure.1 と同様にリブ形状に大きく影響を受けることが分かる.

Figure.1 shows the CT image of soil deformation process with pull out reinforcement material. F rom these images, the occurrence of deformation of soil and the difference of the trend on the shap e of reinforcement material's rib can be observed. Figure.2 shows the result of DIC analysis. From this result, it can be observed that shear strain is concentrated on the area where deformation occurr ed. This also shows the trend is affected from the difference of reinforcement material rib's shape.
